2012 Oak Tree Restoration Planting Project Five Year Progress Report

City of Atascadero
San Luis Obispo County, California

April 2018

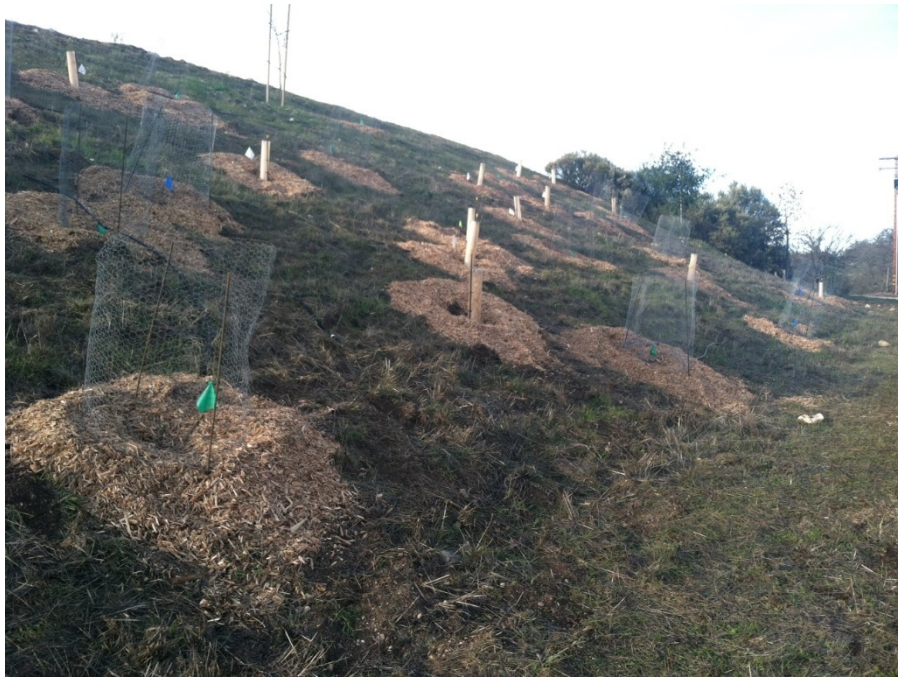
Photo 1. Alondra Road restoration site after initial planting in December 2012. View north.

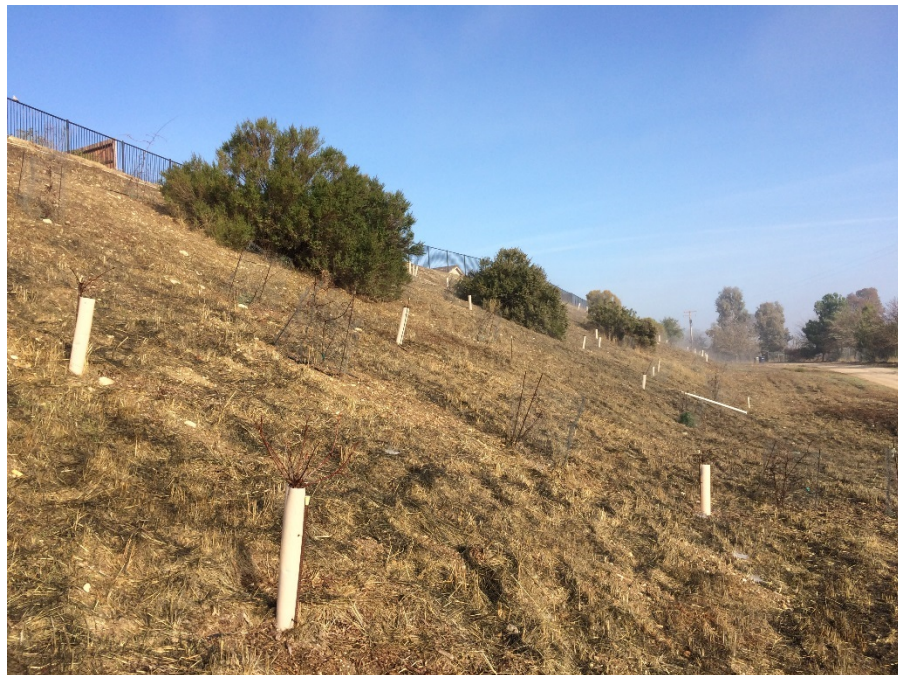
Photo 2. Alondra Road restoration site on January 12, 2018. Note that there are fewer plantings remaining, but the tree tubes and browse protection cages contain oaks that are now from 3 to 5 feet tall. View north.

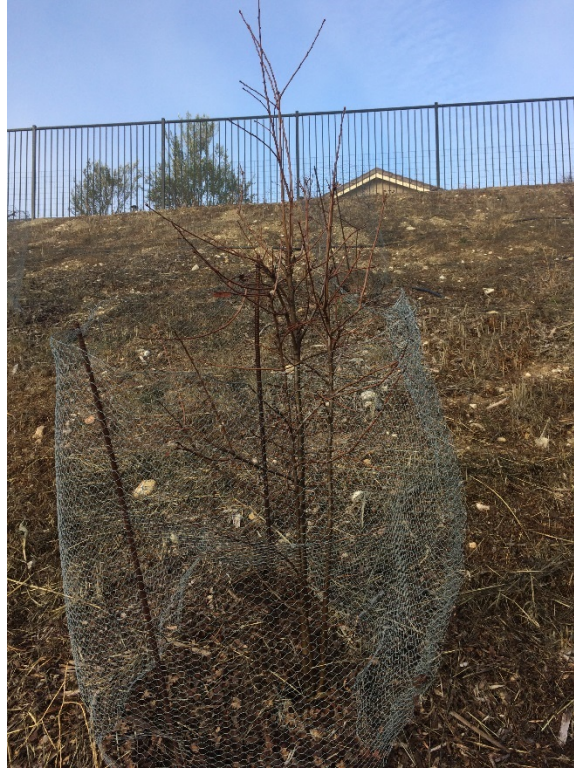
Photo 3. Five-year-old blue oak sapling at Alondra Road. This tree is over 5 feet tall. January 12, 2018.

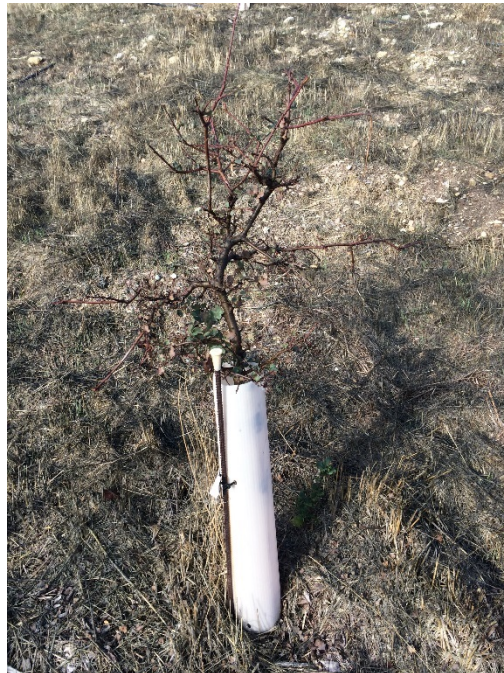
Beginning in 2015, oak trees at Alondra Road and WWTP were large enough to grow out of the tree tubes and browse protection. Browse damage from deer became a problem for the oldest oak seedlings at these sites.

Photo 4. Five-year-old blue oak at Alondra Road; tree is nearly 4 feet tall but has been damaged by browsing. The tree tube will be removed and replaced with a welded wire browse cage. January 12, 2018.

Beginning in mid-2016 and continuing through 2017, new 5-foot-tall welded wire cages were installed around trees that had outgrown the older wire browse protection and tree tubes. These larger, stronger cages protect larger oaks from deer.

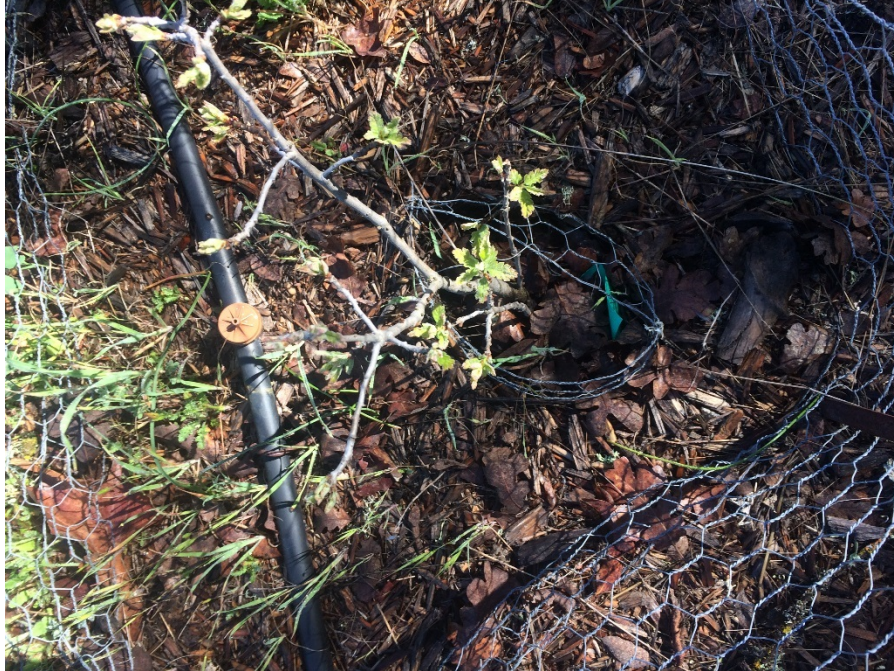
Photo 5. This four-year-old valley oak at Calle Milano is approximately 18” tall. March 23, 2017.

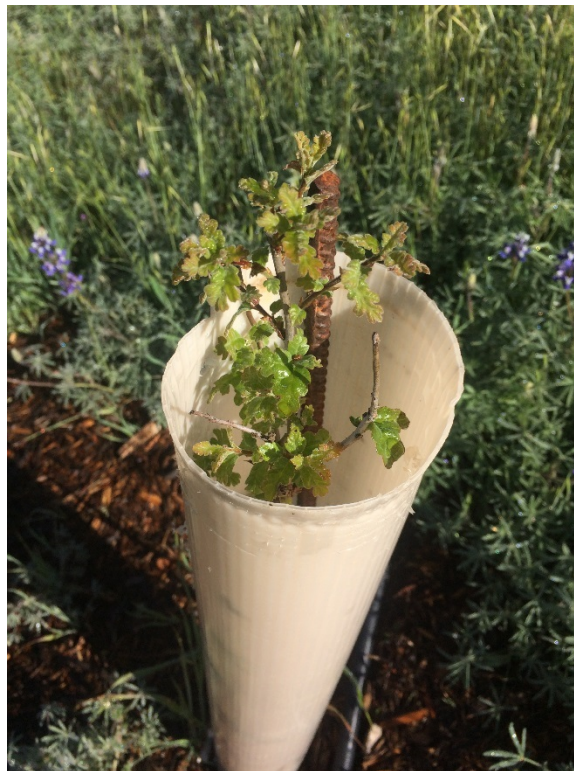
Photo 6. Four-year-old valley oak at Halcon Road. This tree is just over 2 feet tall. March 23, 2017.

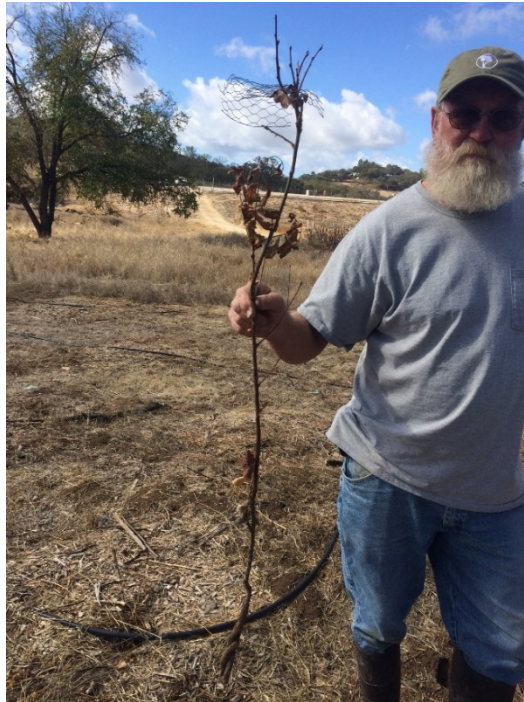
From 2014 onward, the main challenge at WWTP was plant mortality due to gopher damage. It appears that the irrigation of the WWTP site either attracted or concentrated gophers within the planting areas. Even gopher cages were not sufficient to protect the roots of oak trees and other native plants. Gophers were the chief cause of the plant mortality at WWTP and the WWTP expansion site in 2014, 2015, and 2016. In 2017, much less gopher damage occurred. This may be due to the increased rainfall in 2016-17 allowing gophers to disperse into other areas, or perhaps the few surviving plants at WWTP have grown sufficiently to resist gopher predation.

Photo 7. Arborist Cory Meyer at WWTP holding a valley oak killed by gophers. This tree was three years old and over 3 feet tall. November 3, 2015.

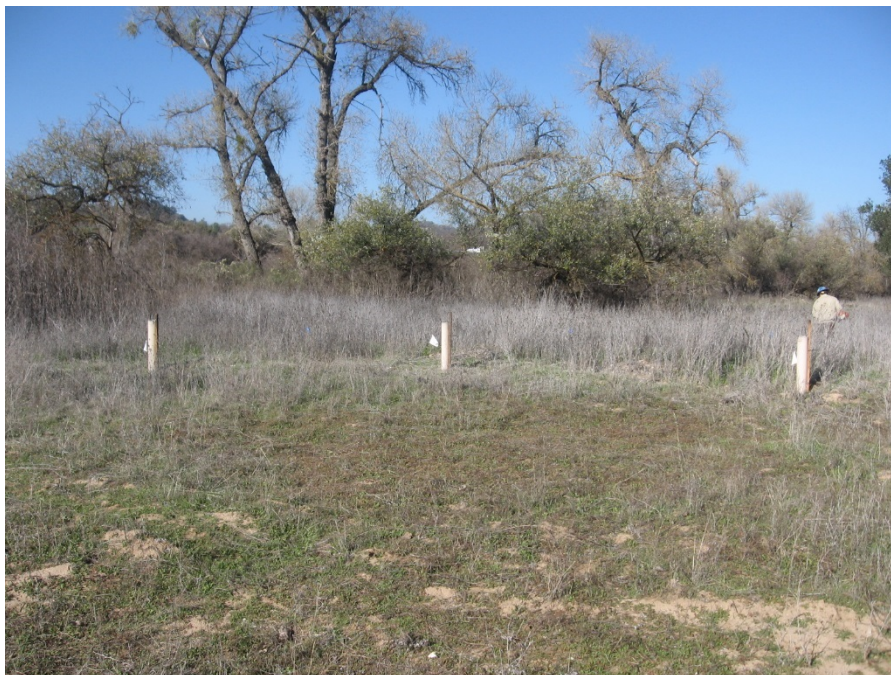
Soil type at each site may also affect gopher predation and plant survival. For example, being adjacent to the Salinas River, the surface soil at the WWTP site features coarse-textured sand and gravel with relatively little clay. This soil layer is approximately 4 to 5 feet deep and its loose

structure allows gophers and other rodents to easily burrow in or tunnel through the soil. Gopher burrows are common at the WWTP site (Photo 7).

Photo 8. Gopher burrows are common throughout the WWTP site due to loose sandy soils. View east. December 11, 2012.

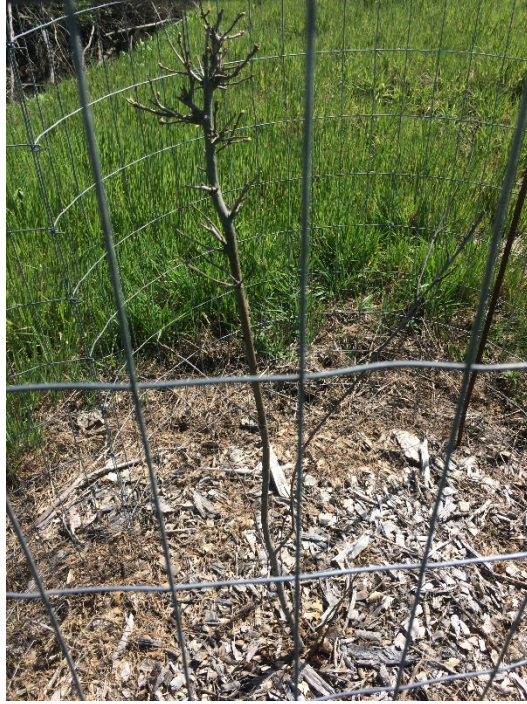
Photo 9. This four-year-old valley oak at WWTP outgrew the tree tube it was planted in. Deer continuously browsed the top until the tree tube was replaced with a larger welded wire cage. March 23, 2017.

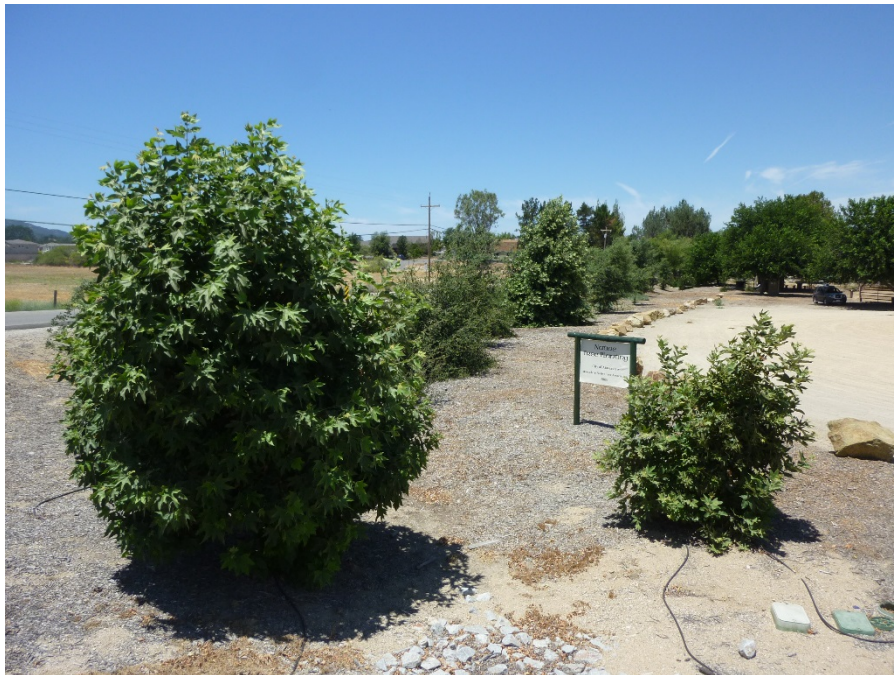
Photo 10. These sycamores (foreground) and oaks (background) at Paloma Horse Arena were 6 years old at the time of this photo. This site was planted in 2009. July 12, 2015.

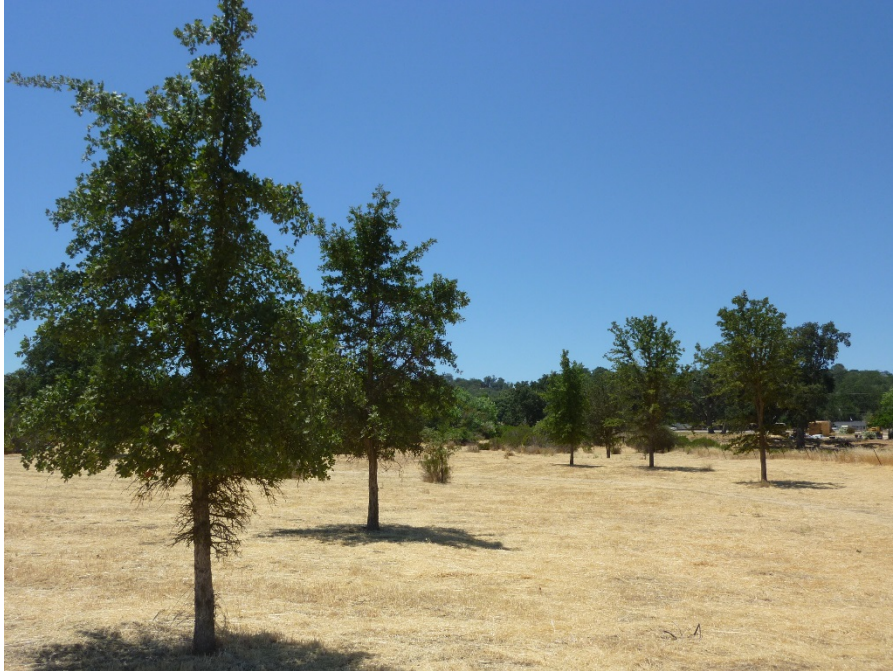
The oldest restoration site in Atascadero is Heilmann Grove. The oldest trees at this site are over 20 years old, and the youngest trees are 11 years old. All oaks have grown to such a size that irrigation is no longer needed and all irrigation tubing and materials have been removed from the site. Based on the success of this site, we expect irrigation materials may soon be removed from other sites.

Photo 11. Oak trees at Heilmann Grove. The trees in this photo are nearly 20 years old. This was the first oak restoration site, planted in 1996, and all irrigation has since been removed. Trees are self-sufficient. July 12, 2015.
